NATIONAL BUREAU OF STANDARDS REPORT

A STUDY OF THE PROPERTIES OF THE U.S. CAPITOL SANDSTONE

Report to the
Architect of the Capitol

NBS PROJECT		NBS REPORT
1001-30-4810	January 8, 1957	4998

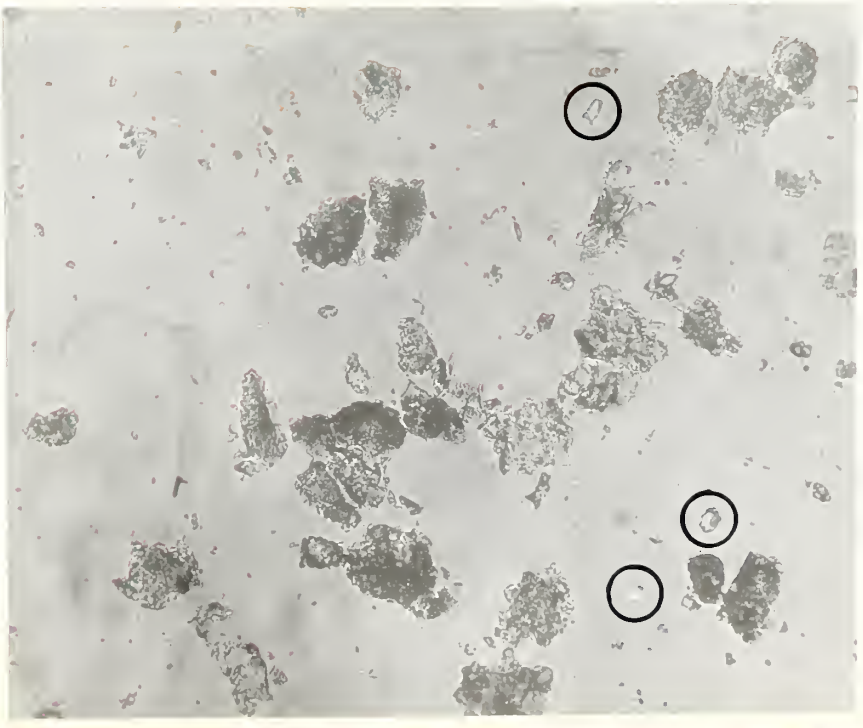
The chemical as well as the mineralogical studies reflect the nature of this stone. It is an "Arkose" sandstone formed from the talus of a decaying granite. The feldspars, in passing over to kaolin due to weathering are responsible for the light color of the stone. Being formed near tidewater, it probably never had sufficient overburden to compact the layers into dense stone.

Fig. 6. Photograph of powdered specimen, representing material from samples of the Capitol sandstone, showing typical alteration products of the feldspar. Encircled clear grains are quartz; dark areas are kaolin. (magnification 200 X)
